The 3.6-m Dome: 30 Years After

Gerardo Ihle, Nelson Montano,
Roberto Tamai (all ESO)

After rotating for more than 30 years, the dome support wheels for the ESO 3.6-m telescope started to degrade, resulting in a shutdown in October 2006. The engineering process of reshaping the track and gradual replacement of the supporting wheels is described. The rotation of the dome is now returning to its original efficiency.

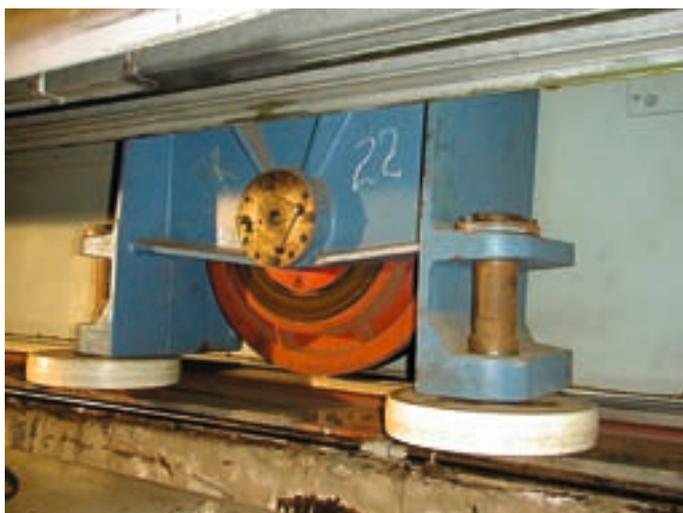
Figure 2: One of the original dome bogies, with the large centred wheel and rubber rim, is shown.

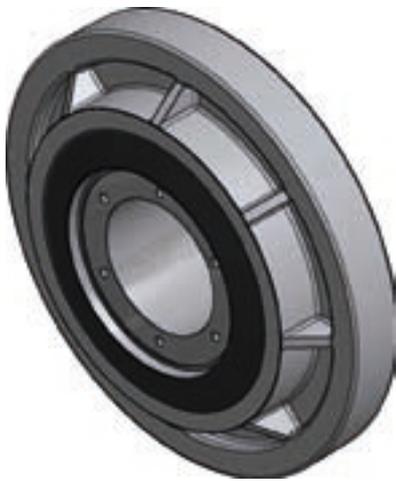
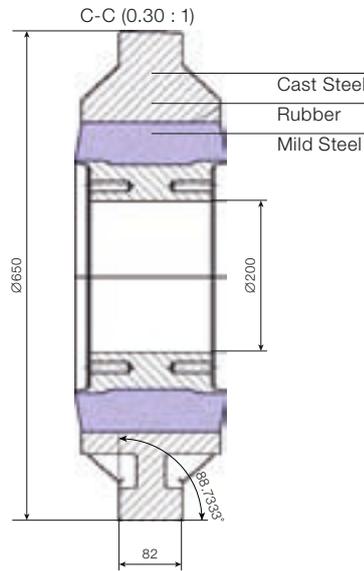
Figure 3: Details of the composite structure of the dome support wheels.

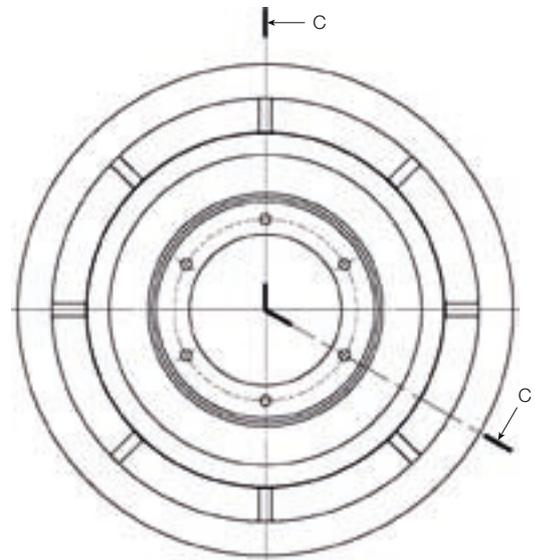
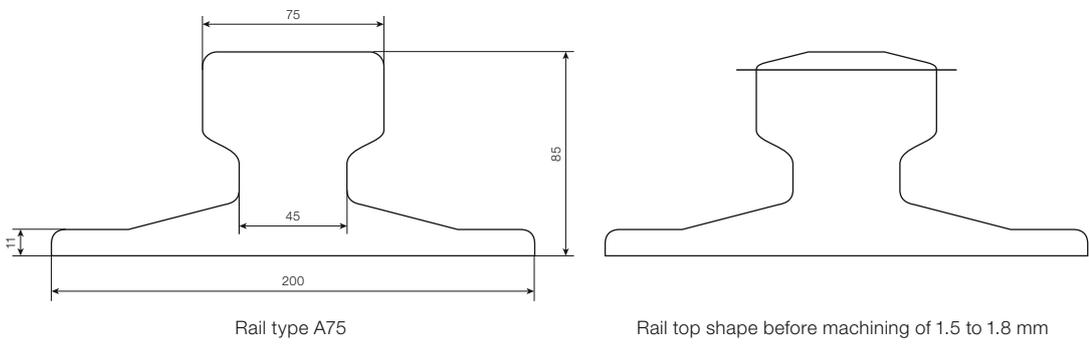
The wheel rims had completely lost their shape (in terms of angle, concentricity with the axis, deformation of the rolling surface, etc.), but so also had the rail lost its top flat surface. The rails had built up an inverted V shape section (see sketch in Figure 4, right). In addition the rail was

Figure 4: Shown left is the original profile of the support rail, and, right, the rail profile after 30 years of use. The rail top was machined 1.5 to 1.8 mm to restore the profile (shown by the line in the right figure).

not flat on a plane but showed hills and valleys around its perimeter.

The condition of the wheels and the rail resulted in unacceptable force during rolling of the wheels, creating excessive stresses in the rubber and rail system. The failure rate thus began to increase.

then conduct a study of the situation of the rail with respect to the enclosure shape and relative dome positioning. Then the re-machining of the outer rim of the wheels to the right shape was done, together with the milling of the top surface of the rail (Figure 4, right) with the help of a specially designed milling head (shown in Figure 5) attached to the rotating part of the dome itself. The centring of the dome was performed by adjusting the two lateral wheels of each bogie. When this was not possible the bogies were re-positioned in order to have the wheels centred on top of the rail. All these activities took place in October 2006, and gave the first results by delivering the dome and telescope back to the community on 4 November.

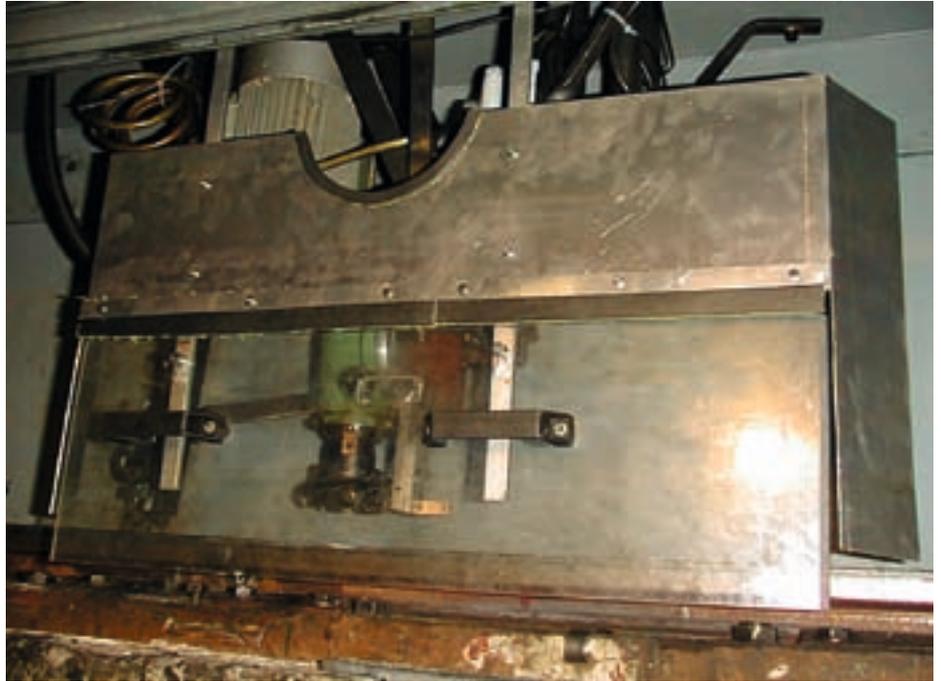
Figure 5: The special milling head, fabricated to machine the rail, attached to the dome.

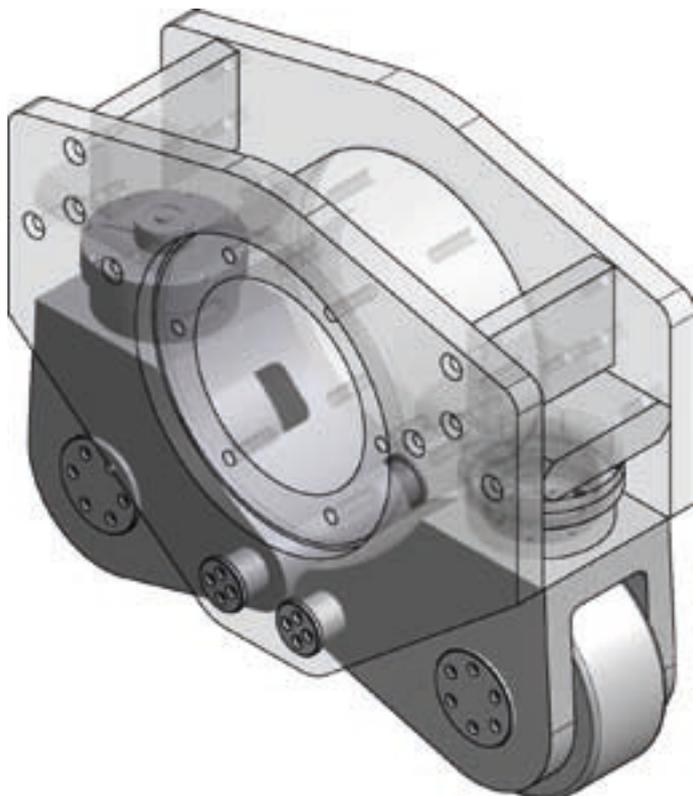
Figure 6: A cutaway showing the design of one of the new dome support wheel units.

After the unsuccessful attempts to find the proper rubber compound for the wheels, a more radical solution to the dome wheel problem was considered: the design and fabrication of entirely new wheel units. Figure 6 shows a cut-away design of one of the new wheel units. The construction is based on a double-wheel carriage supported by friction springs and with the possibility to measure, via load cells, the load applied in the respective bogie. This is an advantage with respect to the original design because it allows a constant control of the load along the rail track.

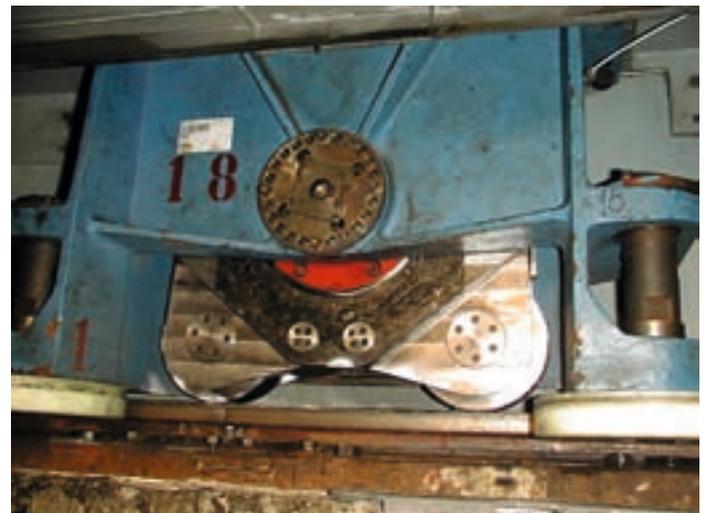
Figure 7: One of the eight new wheel units is shown in position attached to the dome.

The new wheels have so far been installed in eight positions out of 30, and Figure 7 shows one of the installed

units. The loading has been recorded along the rail track and these wheels have helped to relax the loading on the other wheels and thus improve the load distribution of the dome onto the supporting rubber wheels.
