Experience with the operation of the European ALMA antennas

Stefano Stanghellini*, Robert Laing, Silvio Rossi, Wolfgang Wild

European Southern Observatory, Karl-Schwarzschild-Str. 2, 85748 Garching b. München, Germany

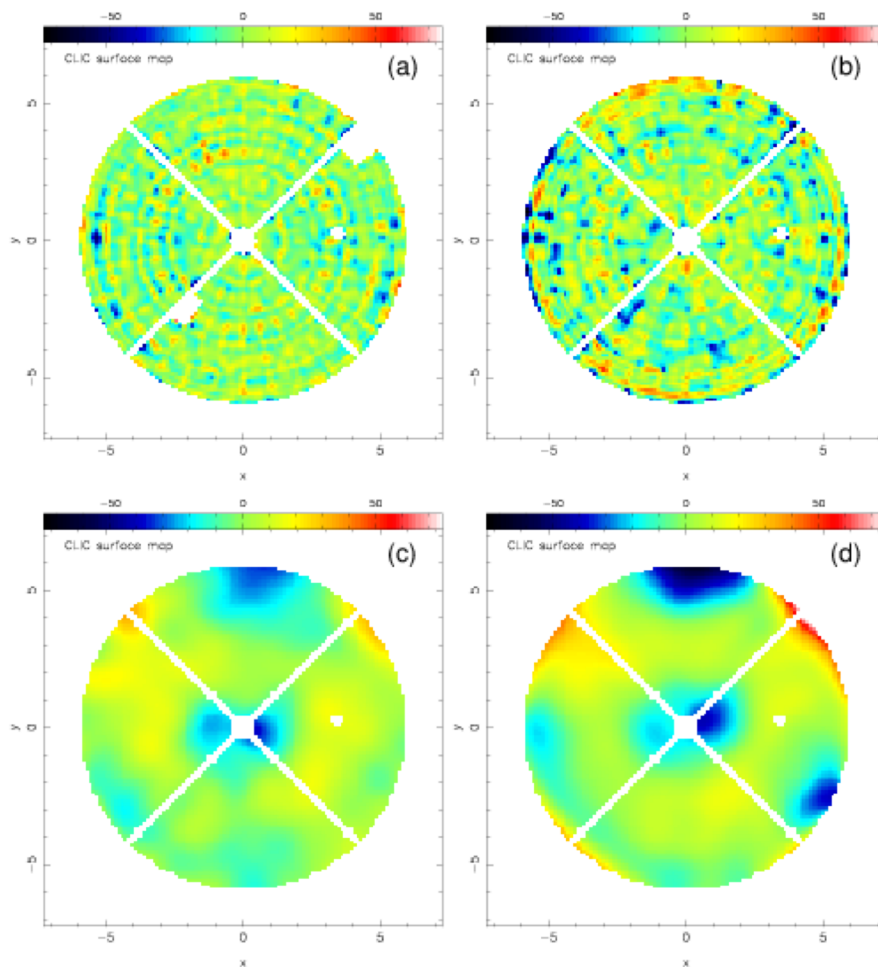
Figure 1: Surface maps derived from holography. (a) primary surface of DA41 after setting at the OSF. (b) as (a), but after two years of operation at the AOS (the same thermal and gravitational model has been applied in both cases). (c) Surface map of DA41 for the full optics (primary and secondary) derived from astrophotography at 230GHz. (d) as (c), but for antenna DA43.

The setting of the primary reflector is done using near-field holography^[2] at the OSF. A dual receiver with a reference horn operating at a frequency of 104 GHz is used and the measurement accuracy is specified to be $<10\mu\text{m}$ rms: in practice, measurement reproducibility was in the range 2 - 4 μm . An example of a measurement of the primary surface just after setting is shown in Fig. 1(a). The residual rms error is 10.9 μm . We have rather little evidence on the evolution of the small-scale surface errors with time, since very few antennas have been returned to OSF for tower holography so far. The best data are for the first antenna, DA41, where measurements after two years operation at AOS show only a slight degradation (to 13.7 μm ; Fig. 1b), primarily in the panel-scale structure. This would not be enough to take the entire optical system out of specification.

The technique used to measure the antenna surfaces at the AOS is interferometric holography^[3] or astrophotography, in which antennas are scanned in a raster or star pattern across a bright quasar, while one or more other elements of the array act as an amplitude and phase reference. This has the advantage that it tests the entire optical system over the full range of operational conditions, including temperature and elevation, but has limited spatial resolution ($\approx 1\text{m}$ on the primary surface). Examples of astrophotography surface maps are shown in Fig. 1(c) and (d). The measured rms errors are 11.3 and 13.1 μm , respectively. Even after allowing for the unmeasured small-scale surface errors, these antennas are both well within the 25 μm specification. Note, however, that the residual large-scale error patterns are very similar for these antennas. This is true in general for all of the European antennas, with a few having significantly worse residuals of the same general form. It seems likely that the consistent residual pattern results from the combination of an incorrect thermal bias introduced during the initial setting and an imperfectly known holography feed-horn correction. The errors are stable in time, temperature and elevation (at least to a first approximation), so the next step in optimization will be to correct the large-scale errors in the surface using astrophotography data from AOS.
