Recent Improvements in the Optical Quality of the La Silla Telescopes

R. Wilson and F. Franza, ESO Optics Section, Geneva

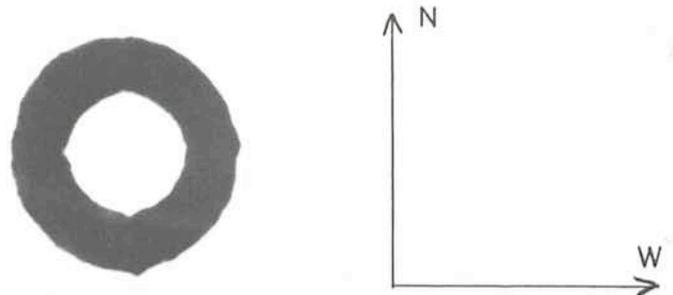
Fig. 1 (ESO 3.6 m telescope): (Pl. 1 p) "Pupil plate" for the 3.6 m telescope showing 0.6 arcsec of decentering coma. A corrector translation of 1.4 mm was required to correct this. (Original image diameter ca. 1.5 mm.)

Figure 1 (Pl. 1p) shows a typical pupil plate before recentring, corresponding to 0.6 arcsec of coma and requiring a shift of 1.4 mm of the corrector. Figure 2 (Pl. 3p) shows the result after final centering—the residual error here is < 0.3 arcsec and is near the limit of detectability with the moderate seeing at the time.

the outer one. By applying certain conversion factors, the coma and the necessary shift of the corrector can be deduced from this asymmetry. It is also possible to determine other defects from such pupil plates, notably astigmatism and spherical aberration. The precision obtainable depends on the seeing, particularly the "internal" dome seeing which gives pupil distortions which cannot be integrated out by longer exposures.

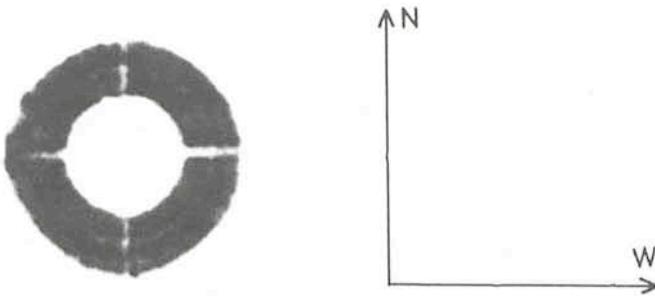
Fig. 2 (ESO 3.6 m telescope): (Pl. 3 p) "Pupil plate" for 3.6 m telescope after centering to <0.3 arcsec of coma. The judgment of symmetry of the pupil was made at 45° to the spider to avoid local turbulence disturbance. (Original image diameter ca. 1.5 mm.)

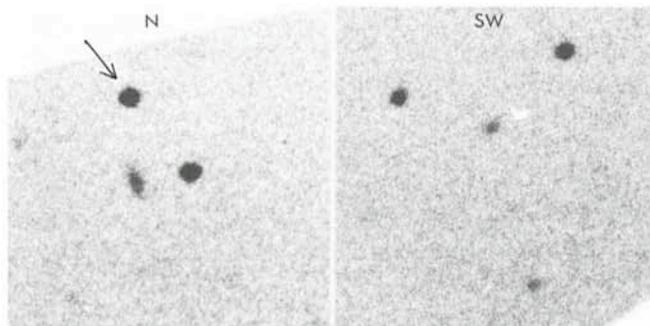
Fig. 3: Two fields from the extreme edge of a plate taken with the 3.6 m telescope at the prime focus by Hans Schuster of NGC 55 (45 min on baked IIIa-J with filter GG 385). At the extreme edge of the field in the N direction (left field), slight asymmetry of star images is detectable on the original where the theoretical edge field coma (ca. 0.25 arcsec) has vectorially approximately added to the small decentering coma residual (ca. 0.25 arcsec uniform over the whole field). The second field in the SW direction shows no detectable asymmetry on the original because the coma vectors have approximately subtracted.

Figure 3 (Pl. 8p) shows a test photo of NGC 55 kindly taken and guided by our colleague Hans Schuster using a baked IIIa-J plate with filter GG 385. The exposure time was 45 mm and the zenith distance about 20° – 25° . The seeing estimate was about 2 arcsec and the smallest images are about $1\frac{1}{2}$ arcsec. At the edge marked with the arrow, it is possible on the original to detect a slight asymmetry due to coma. This corresponds to the side of the field where the residual decentering coma (about $\frac{1}{4}$ arcsec, and constant in amount and direction over the whole field) adds up vectorially with the theoretical residual of the corrector field coma (about $\frac{1}{4}$

arcsec at the edge of the field and radially directed towards the centre of the field). This demonstrates that, even with moderate seeing, very high centering precision is worthwhile if top-quality results are desired.

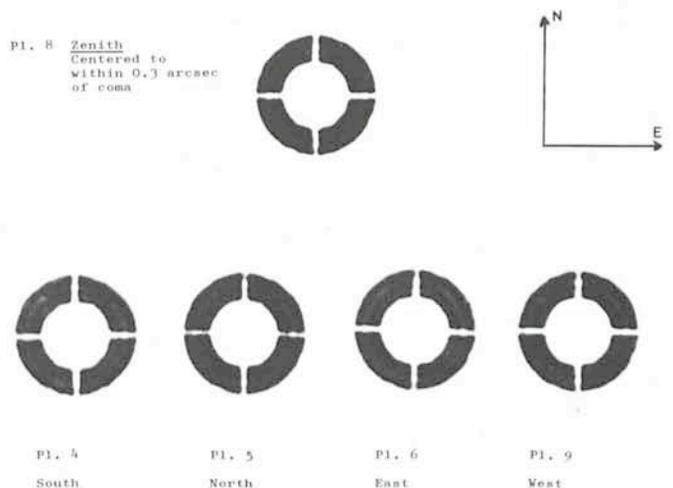
Centering was then performed by "pupil plates". Figure 4 shows a pupil plate for the zenith after centering to a coma of < 0.3 arcsec and similar plates for inclinations of about 45° in the S, N, E and W directions. The negligible variation of coma proves the excellent mechanical rigidity of the telescope.

Fig. 4 (Danish 1.54 m telescope): After centering in the zenith to the quality shown in Pl. 8, the telescope was inclined at about 45° in all four directions. The pupil plates show a negligible variation proving the excellent mechanical stability of the telescope. (Original image diameter ca. 2.5 mm.)

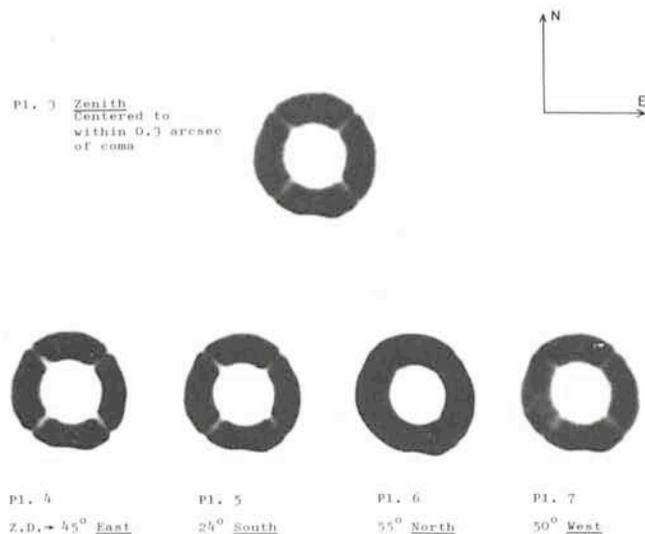
The 1 m telescope has been the subject of complaints for a long time regarding image quality and stability. Above all, its performance was erratic and alignment was not maintained. We suspected that most, if not all, these problems were attributable to the state of the prime mirror cell. We were most fortunate in having with us last November Jan van der Ven who had designed this cell fifteen years ago while working at Rademakers in Holland! With his help, it was found that the prime mirror had probably never been correctly mounted in the cell and that certain minor mechanical modifications were necessary to facilitate correct mounting. After 3 days of hard work (including weighing the mirror on a wonderful balance constructed by Jan, to make sure the support loads were set to an optimum) the primary was correctly mounted in its cell and the telescope ready for test during the one available night. Unfortunately, the seeing was rather poor, particularly within the dome due to the disturbance of the day-time work. The centering was done, as before, with pupil plates, but the quality of the pupil plates, even integrated for 4 m, was poor. Also, the judgment of the plates was made more difficult in the N-S direction by a small mechanical vignetting of the pupil whose origin we had no time to trace. Nevertheless, centering within about 0.3 arcsec was still possible. *Figure 5* shows the results. Pl. 3 shows the final centering state after two iterations of correction. Pl. 4 to 7 show results with the telescope inclined in various directions. There is evidence of coma variation in the W plate (zenith distance $\sim 50^\circ$) indicating a small error in the performance of the tube (Serrurier truss); but the astigmatism of about 1.2 arcsec is more serious. The present evidence is that astigmatism appears in a constant direction (independent of telescope azimuth) following the spider on inclining

Fig. 5 (ESO 1 m photometric telescope): After centering in the zenith to the quality shown in Pl. 3, the telescope was inclined at the zenith distances shown in the four directions. The pupil plates in the inclined positions show astigmatism up to 1.2 arcsec in the N and W positions and some coma in the W position (Serrurier truss error). (Original image diameter ca. 2.5 mm). Note that both dome turbulence and external seeing were very bad, giving poor quality pupil image. Note, too, the vignetting at the south edge of the pupil.

the telescope, but the *amount* increases with telescope inclination. The evidence suggests the cause is in the secondary support but there was no time to investigate this further—we hope to do so next August.

The reproducibility of centering between Pl. 3 and Pl. 8 seems to confirm that the telescope is at last *stable* and maintaining its adjustment. Stability is obviously a sine qua non of satisfactory telescope performance.
