## The La Silla News Page

## Improving Image Quality at the Danish 1.54-m Telescope

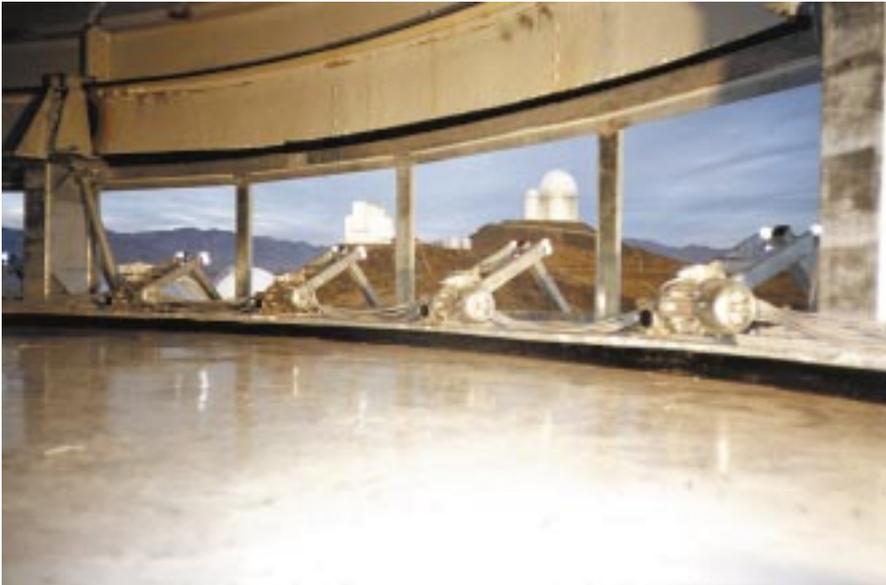
Figure 1: View of the open ports from the inside of the dome.

Figure 1 is a view of the open ports seen from the inside of the dome. The ports are split into 8 sectors of 4 ports each, and it is possible to open or close any of the sectors separately. This will allow the system to be used in strong wind conditions when wind-borne dust is of concern and the dustladen wind must be kept from entering the telescope building. The system is mechanically simple and should require minimal maintenance. For simplicity, it is planned initially to apply the standard La Silla wind limits for domes also to the ports; i.e., all ports may remain open if the wind speed is less than 14 m/s, while ports in the wind direction should be closed when the wind speed is above 14 m/s. At wind speeds greater than 20 m/s, all ports (and, of course, the dome itself), must remain closed.

After commissioning a number of cost/benefit engineering studies, it was decided by Copenhagen University Observatory (CUO) to implement a natural ventilation solution by raising the entire dome by 70 cm and installing side ports in the space between the dome and the building. A similar system is already in use at the Nordic Optical Telescope on La Palma, Spain, and will be used at the new Swiss telescope at La Silla. It was agreed with ESO that this would be supplemented by an effort to improve the thermal insulation and the performance of the existing ventilation and cooling systems in the building (which, unlike the telescope itself and the dome, is ESO property).
